**Resource Assessment
to Evaluate Ecological & Hydrodynamic Responses
to Reinstalling a Water Control Structure
in the Muddy Creek Dike**

**University of Massachusetts Dartmouth
School for Marine Science and Technology**

**Applied Coastal
Research & Engineering**

FINAL REPORT - DECEMBER 2008

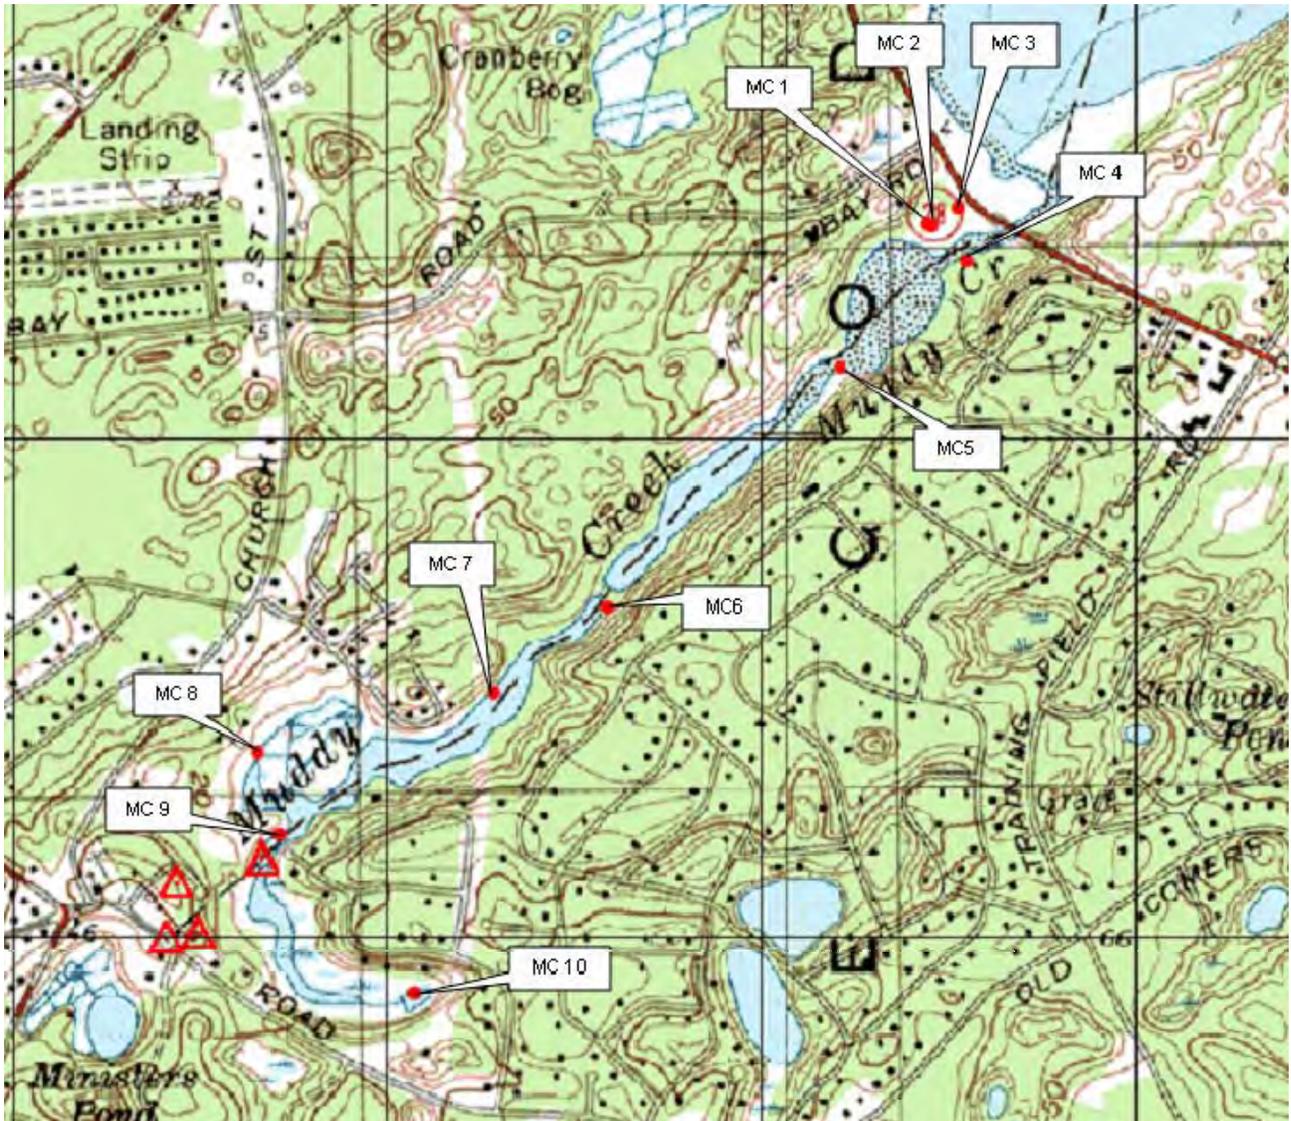
Figure 4 Locations of sediment core sites (red dots labeled MC 10) for determining porewater salinities of wetland areas within the Muddy Creek System. Red triangles show locations of benchmarks.

A total of ten wetland sites were sampled, 5 above and 5 below the dike site (Figure 4, Table 1). Intact sediment cores were extracted from the sediments at each site using 6.5 cm (inside diameter) polycarbonate tubes. Cores were then cut into 5 cm sections to allow assay of the 0-5 cm, 5-10 cm and 10-15 cm depths within the root zone. Pore waters were extracted and analyzed for salinity based upon specific conductivity measurements at the SMAST Analytical Facility (see Appendix D).

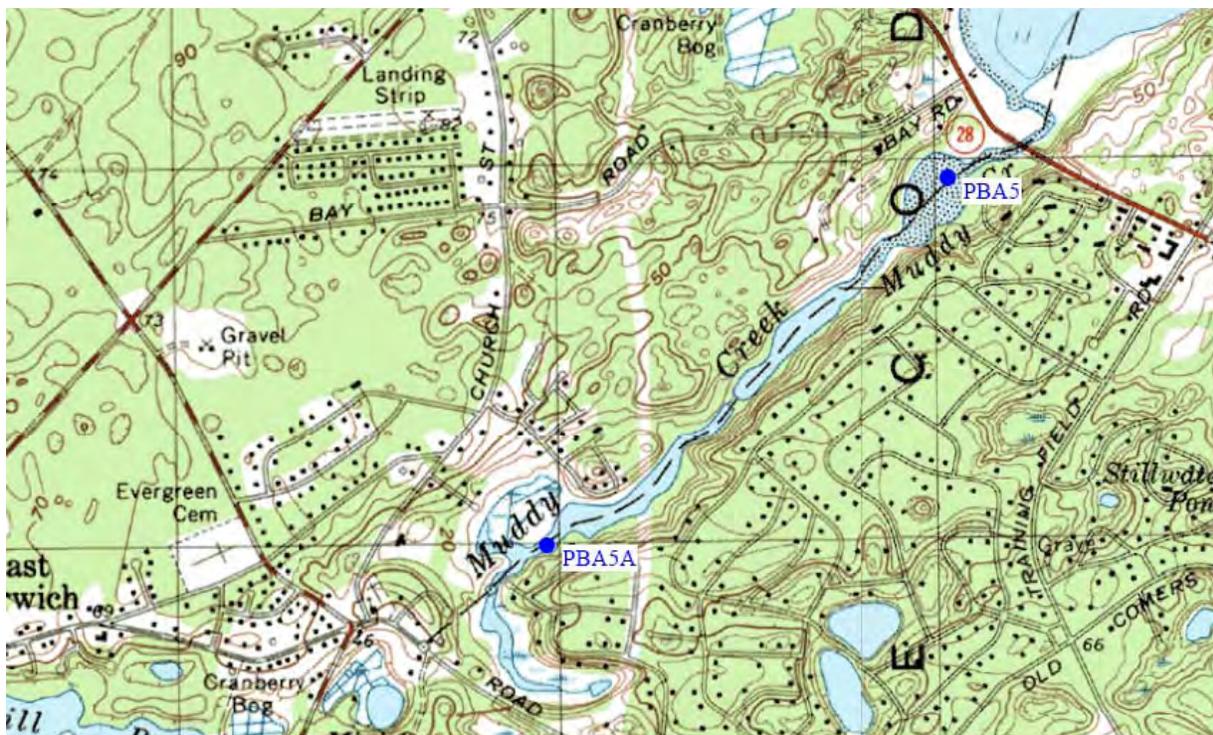
Figure 8. Locations of water quality stations, Muddy Creek, MA

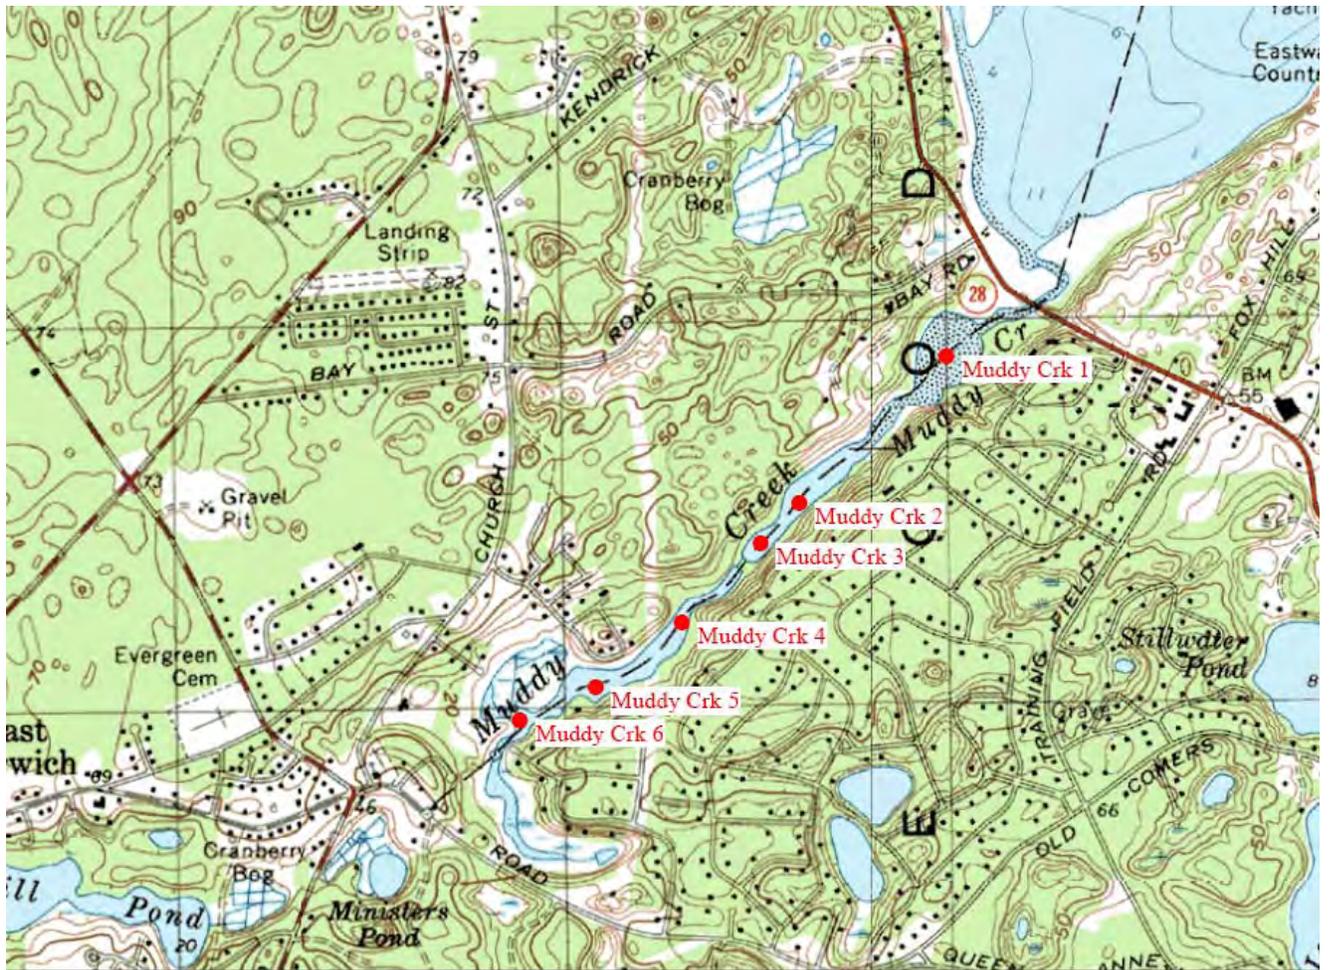
Figure 10. Locations of benthic infauna sampling stations, Muddy Creek, MA.

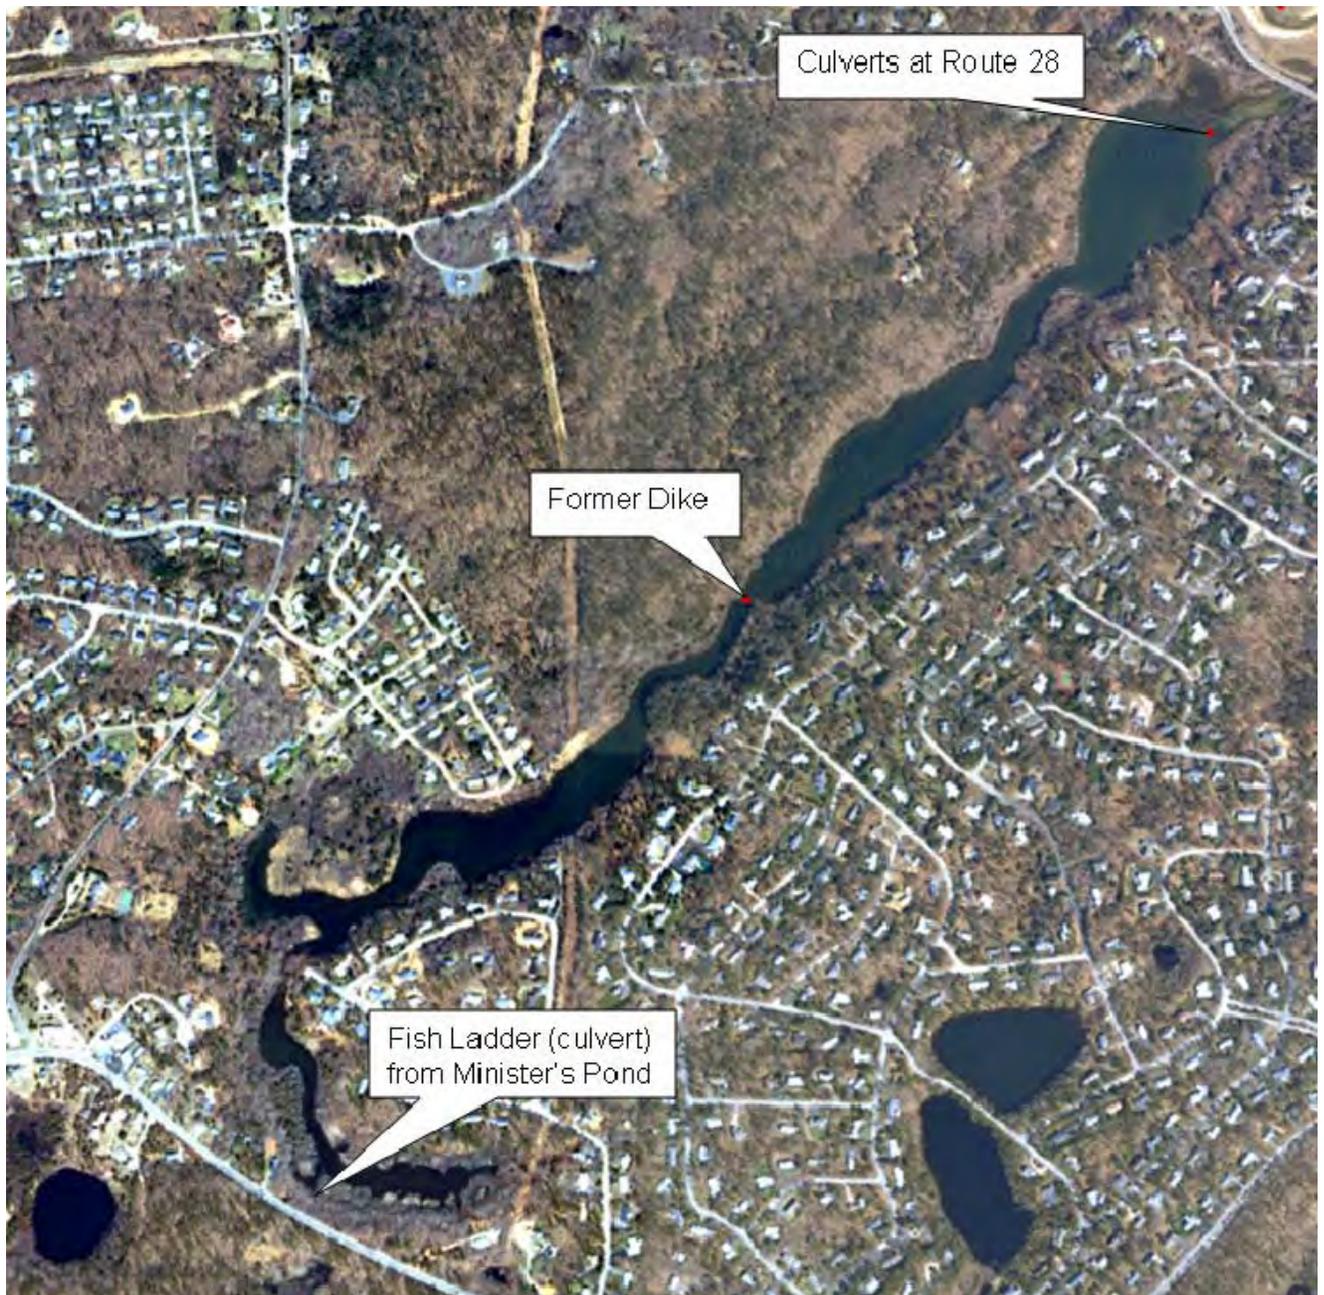
Figure 12 Anadromous fish runs, Muddy Creek. The fish runs relate to the present (culvert at Rt. 28 and Minister's Pond fish ladder) and historical (dike) restrictions to fish passage. Source, MassGIS.

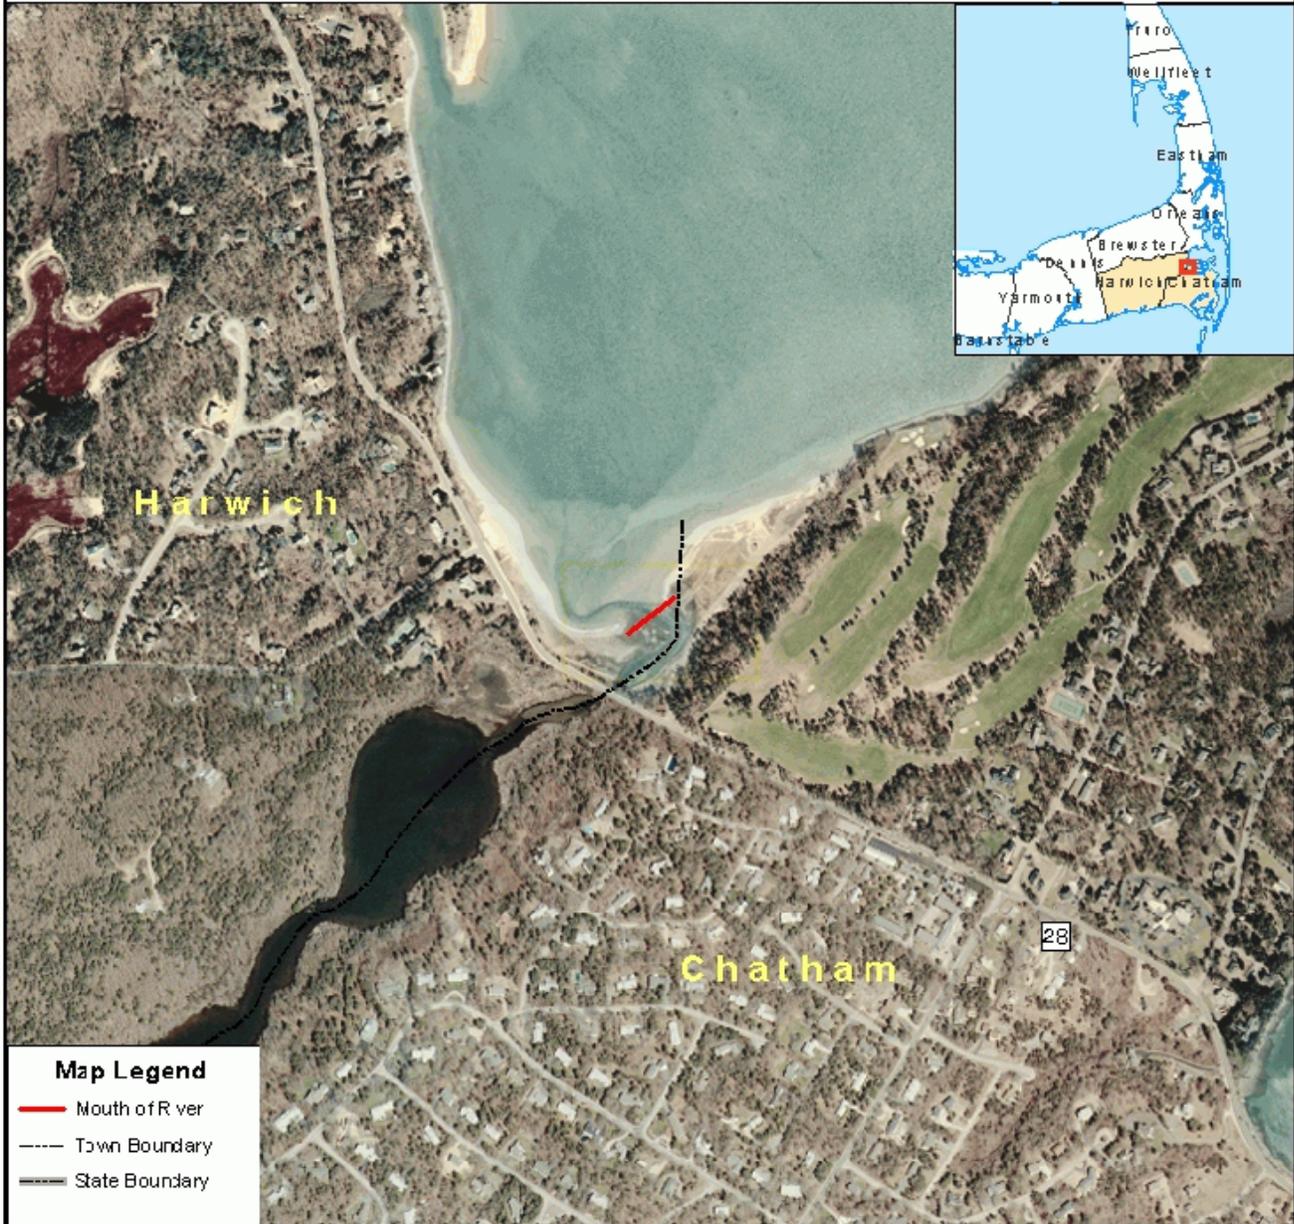
Figure 15 Mouth of a coastal river as designated by MassDEP under the Massachusetts Rivers Act. The Red Bar represents the furthest extent of the coastal river (drown river valley estuary), the performance standards of the Act apply to the river reach inland of the mouth.
