THE MASSACHUSETTS ESTUARIES PROJECT

BACTERIA TMDL FOR MUDDY CREEK

Report # MA96-51-2004-01

*Chatham & Harwich Massachusetts
Cape Cod Watershed*

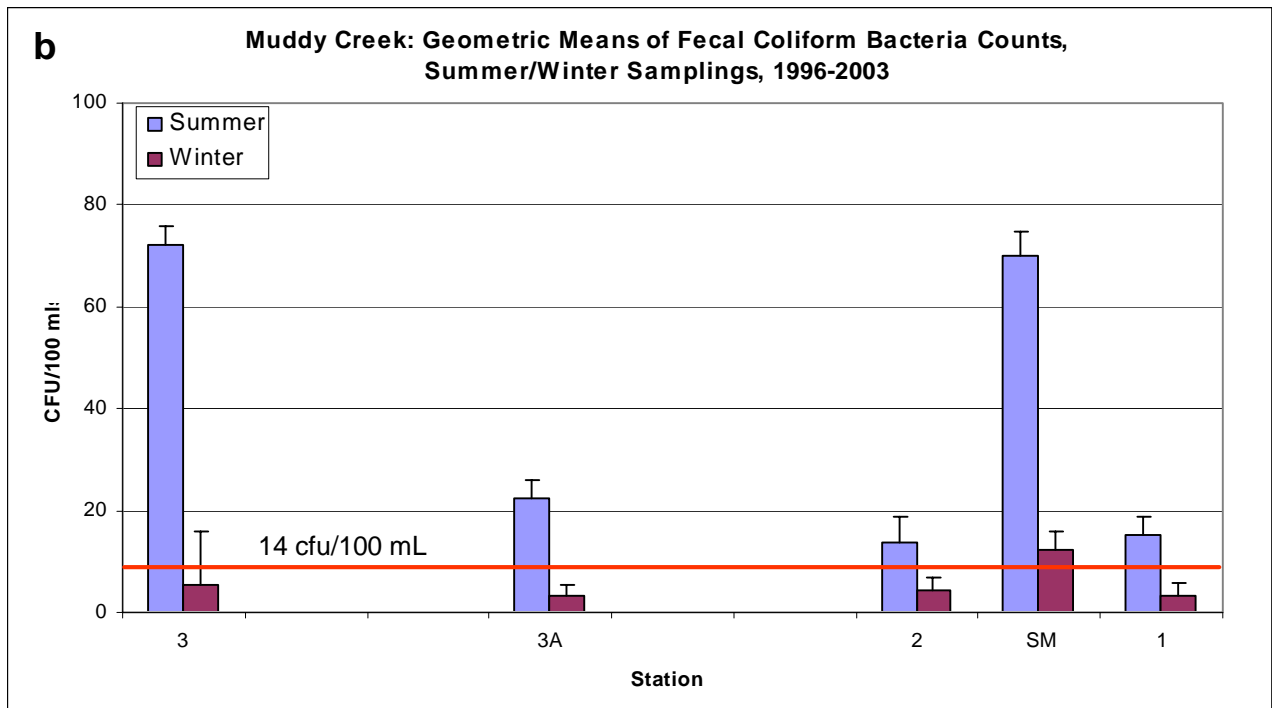
Figure V-4 Summer and winter Fecal Coliform bacteria counts (CFU/100 mls) during the years (a) 1985-1995 and (b) 1996-2003. Numbers indicate geometric means for summer/winter samplings by Massachusetts Division of Marine Fisheries, Town of Chatham Water Quality Department and SMAST (SM).

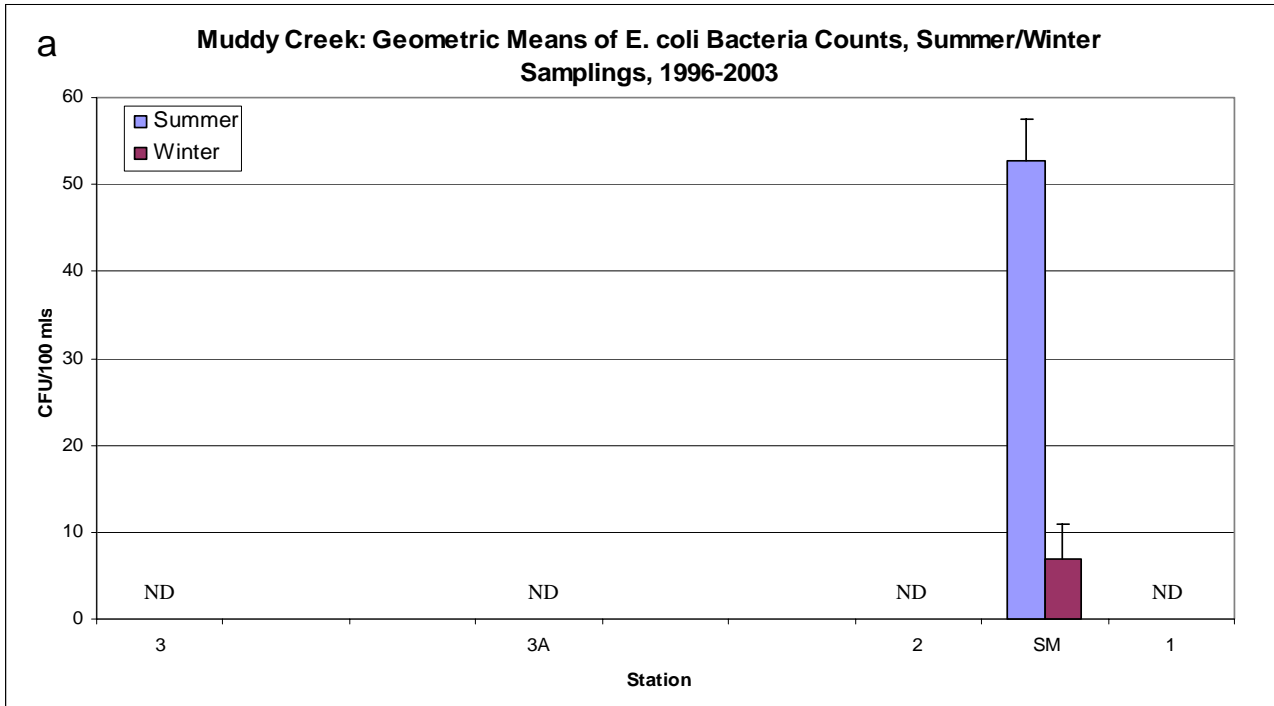
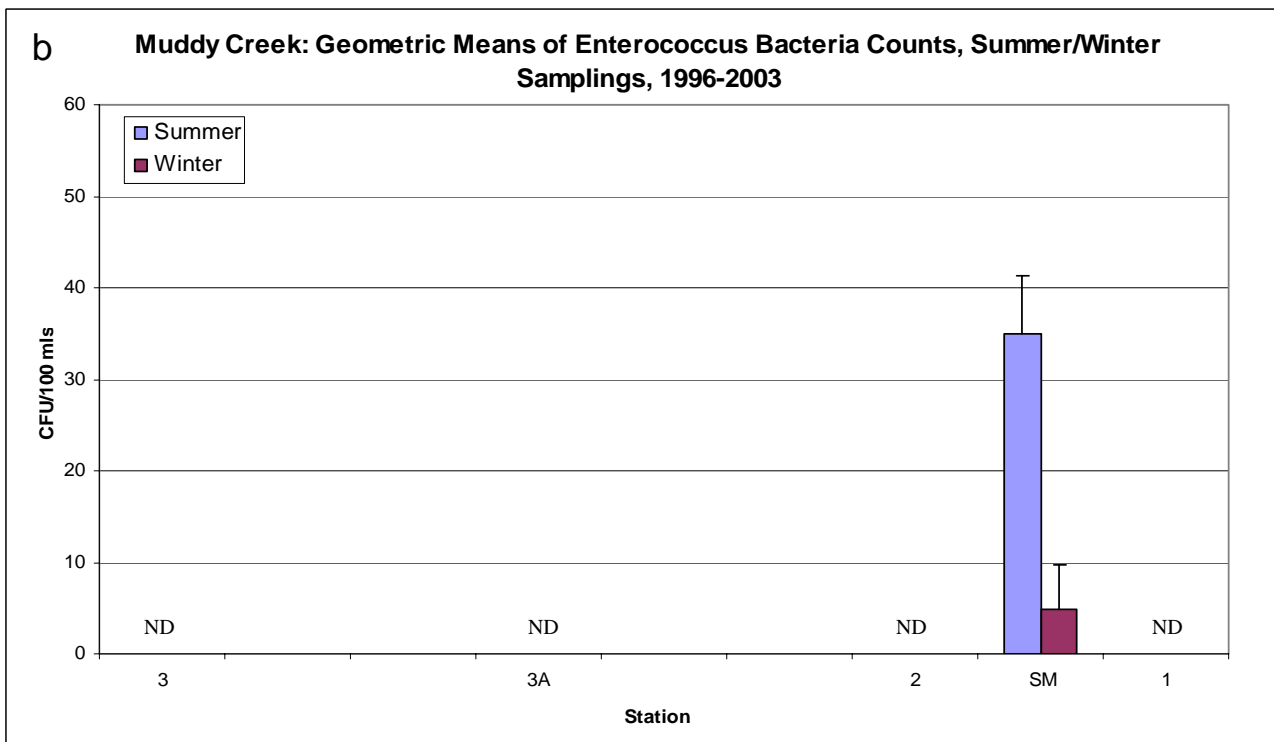
Figure V-5 Summer and winter *E. coli* (a) and *Enterococcus* (b) bacteria counts (CFU/100 mls) during the years 1996-2003. Numbers indicate geometric means for summer/winter samplings by SMAST (SM).

For E. coli, there were 4 wet and 10 dry samples in the summer, and 13 wet and 5 dry samples from the winter at Station SM. The summer wet weather geometric mean was 159 CFU/100 mL, while the dry mean was 56 CFU/100 mL. Both means exceeded the water quality standard of 43 CFU/100 mL and more than 10% of the samples exceeded the water quality standard of 43 CFU/100 mL (Table V-3b). The wet mean to dry mean ratio was 2.8, indicating that *wet inputs were approximately 3 times higher than dry inputs in the summer*. The winter wet and dry geometric means at Station SM were 7 CFU/100 mL. Neither exceeded the water quality standard and only the wet samples had more than 10% above the water quality standard of 43 CFU/100 mL. *The wet mean to dry mean ratio at SM for the winter was 1.0, indicating that wet and dry inputs were equivalent* (Table V-3b).

For *Enterococcus*, there were 4 wet and 10 dry samples in the summer and 4 wet and 5 dry samples in the winter. The summer wet mean at Station SM was 119 colonies/100 mL and the dry mean was 51 colonies/100 mL for a wet mean to dry mean ratio of 2.3, *indicating that wet inputs were approximately 2-3 times greater than dry inputs in the summer and both weather conditions exceeded the water quality standard of 35 colonies/100 mL*. Seventy-five per cent of the wet samples in the summer and 40% of the dry samples exceeded the water quality standard of 104 (Table V-3c). The winter wet mean was 8 colonies/100 mL and the dry mean was 12 for a wet mean to dry mean ratio of 0.7, indicating that wet inputs in the winter were slightly less than dry inputs (Table V-3c). Neither mean exceeded the water quality standard of 35 and 8% of the wet samples exceeded the water quality standard of 104 colonies/100 mL.

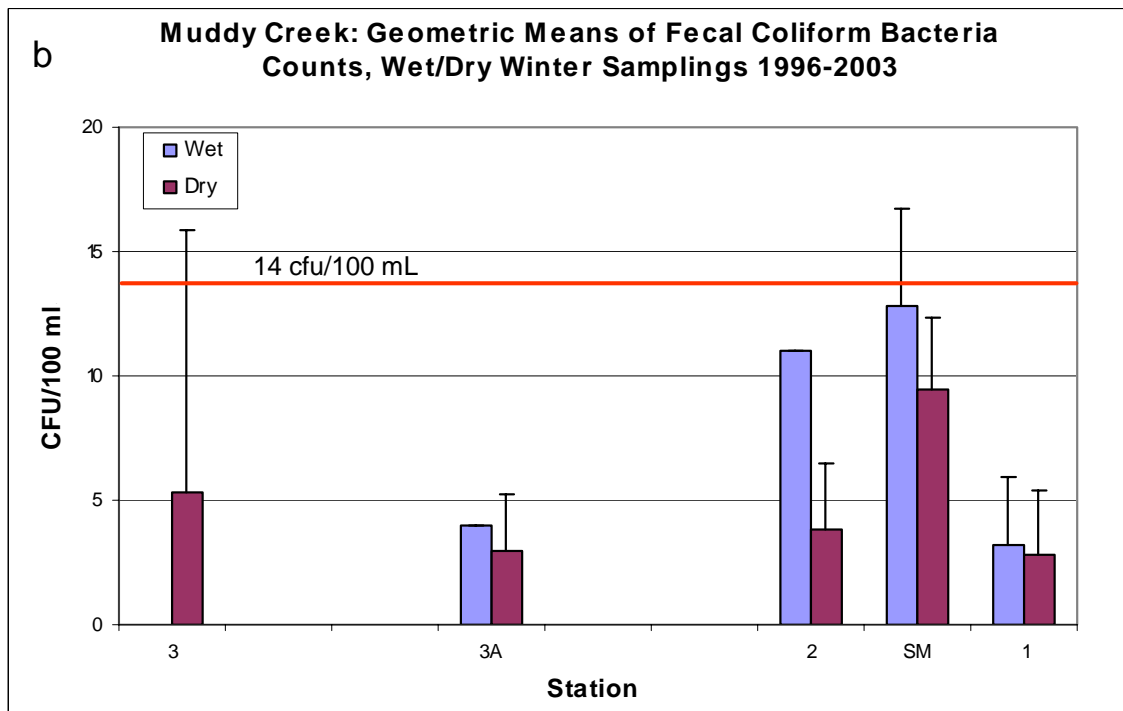
Figure V-6 Summer (a) and Winter (b) wet and dry weather fecal coliform bacteria counts (CFU/100 mls) during the years 1996-2003.

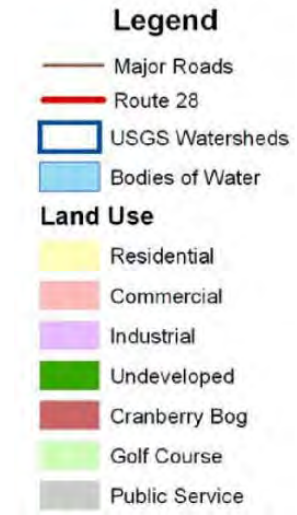
Sta. 3	ND/5
Sta. 3A	4/3
Sta. 2	11/4
Sta. SM	13/9
Sta. 1	3/3

Figure V-10. Land-use by parcel for the Muddy Creek system relative to DMF and SMAST sampling station locations.

“Stop light” symbols indicate geometric means for wet/dry /winter fecal coliform samplings (CFU/100mL) during the period 1996 – 2003

The SMAST data set is incorporated into Figures V-9 and V-10 where bacterial concentrations relative to land use is identified at Station SM during summer wet/dry weather conditions and winter wet/dry conditions respectively as well as DMF stations 1, 2, 3A, and 3. During summer months exceedances occur primarily at stations 3 (DMF) and station SM (SMAST) during both wet and dry conditions. Station 3 is located in upper Muddy Creek (shoreline classified as residential, public service: municipalities, districts, charitable organizations, churches, and undeveloped: zoned residential). SMAST station SM is located in lower Muddy Creek proximal to the Route 28 culvert separating lower Muddy Creek from the mouth of Muddy Creek discharging to Pleasant Bay. As previously discussed, it is recommended that further focused investigations be undertaken in these “most contaminated” sections of Muddy Creek. Runoff from Route 28, a storm drain off Sugar Hill Road as well as other local roads, diffuse runoff from the Chatham Town Landing, and inputs from the wetlands at the head of the Creek are areas that should be investigated further. Summer exceedances also occur at stations 3A and 2 (DMF) located in lower Muddy Creek under dry conditions. Both these stations are located proximal to a large portion of the lower Muddy Creek watershed that has been classified as undeveloped land (zoned residential). These exceedances may be the result of waterfowl and wildlife populating this undeveloped land during summer months. Data obtained under winter wet/dry conditions show no exceedances. The pattern of contamination and its response to rainfall support the contention that wildlife are important to bacterial contamination in the upper and general area of the lower basin and that runoff dominates the contamination found near the tidal inlet. The fact that conservation and undeveloped land forms a near continuous “buffer” around the Muddy Creek shoreline adds support to the source conclusions.
